# Manhole Inspection Summary

Manhole # **S15AA\_016MH**

Insp Date: **8/7/09 9:10 AM**

**Location** Address: **LAFAYETTE AVE**

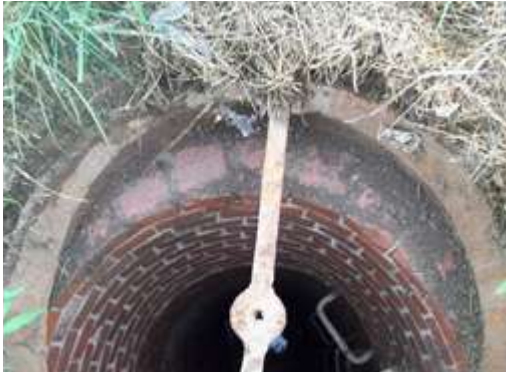
Defect 1

Offset: **6** (in.)

OFFSET

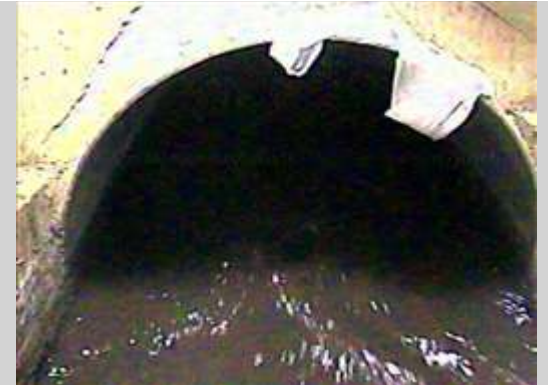
12 O'Clock Outflow

33 in. Circular Gravity Sewer  
Pipe Out @ 12 O'Clock

Invert Depth: **10.05** (ft.) Flow Characteristics: **Fast**

Infiltration: **None**

Pipe Seal Cond: **Sound**

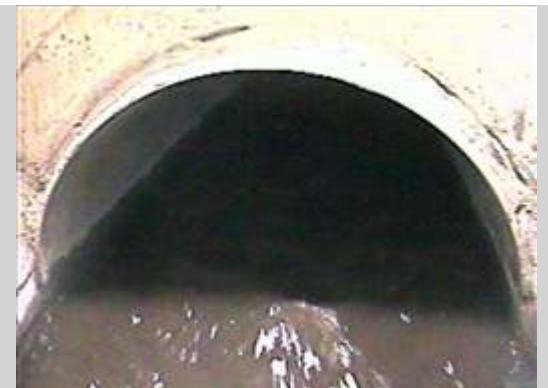
6 O'Clock Inflow

33 in. Circular Gravity Sewer  
Pipe In @ 6 O'Clock

Invert Depth: **23.10** (ft.) Flow Characteristics: **Fast**

Infiltration: **None**

Pipe Seal Cond: **Sound**

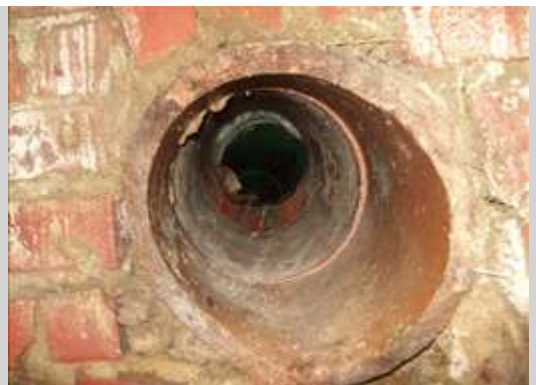
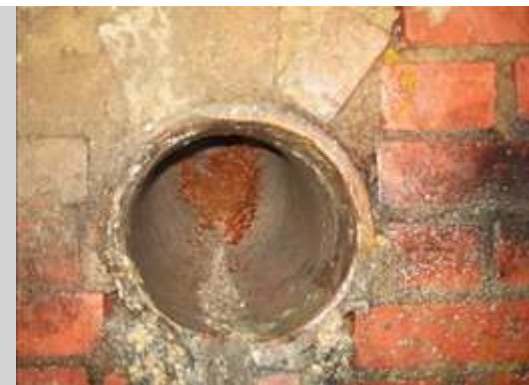
8 O'Clock Inflow

8 in. Circular Gravity Sewer

Pipe In @ 8 O'Clock

Drop In @ 8 O'Clock

Drop: **Outside** **Direct**

Drop Condition: **Open**
